Case Study

Roof Installation in the Winter of 2018 in Atlanta, Georgia

Images of Construction Prep

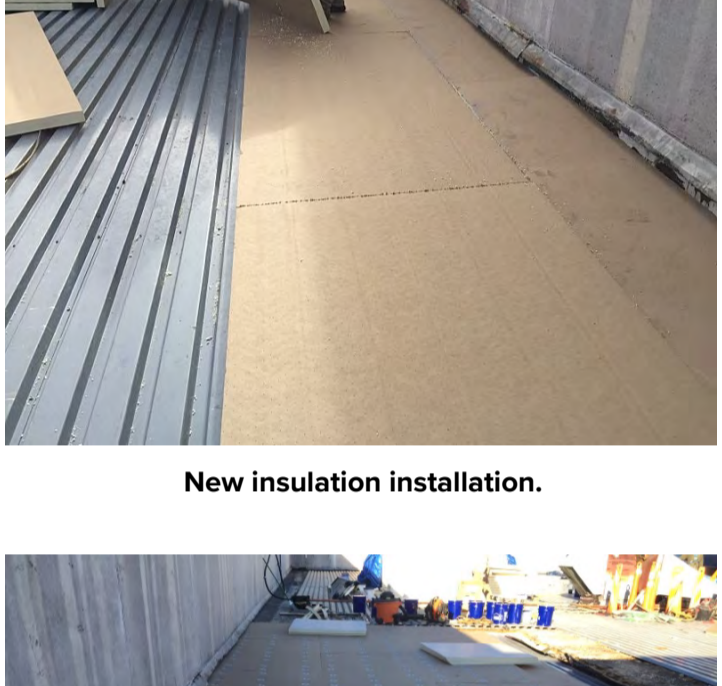
New look of the same detail.

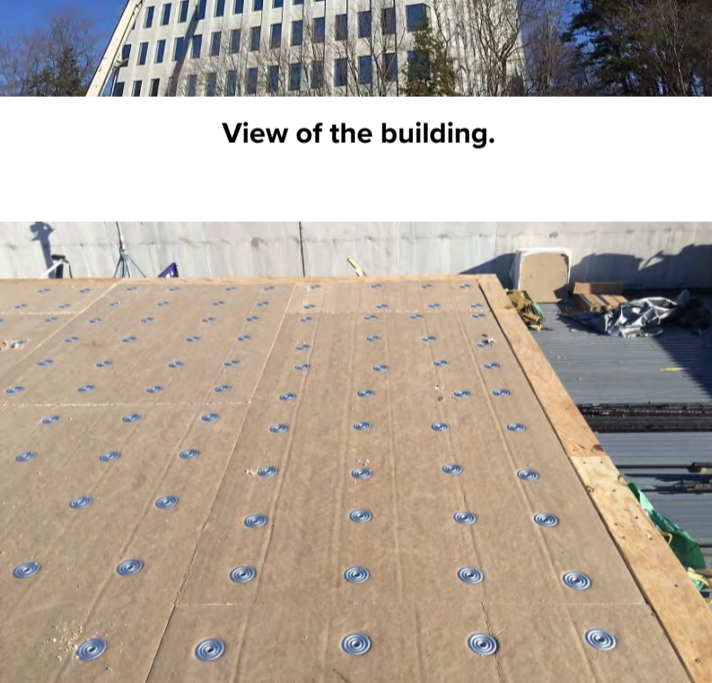
New deck mechanical fastener.

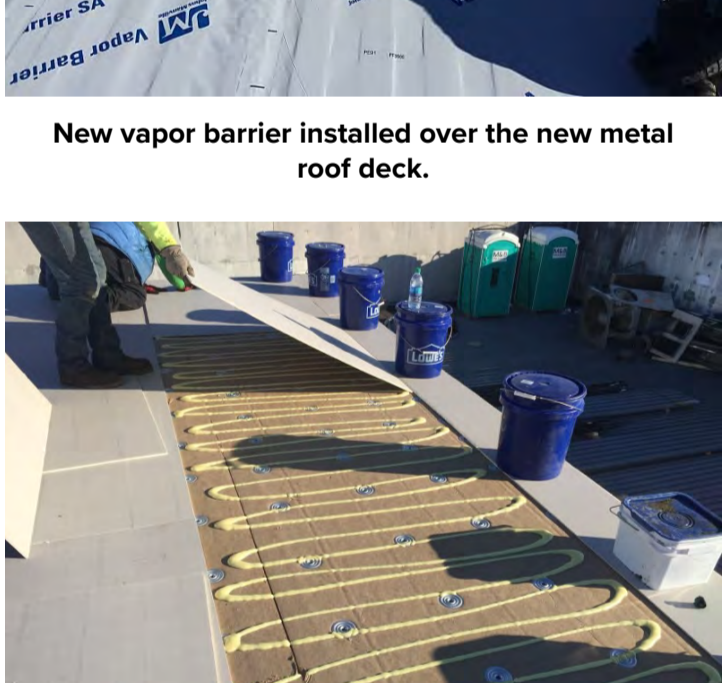
New insulation installation.

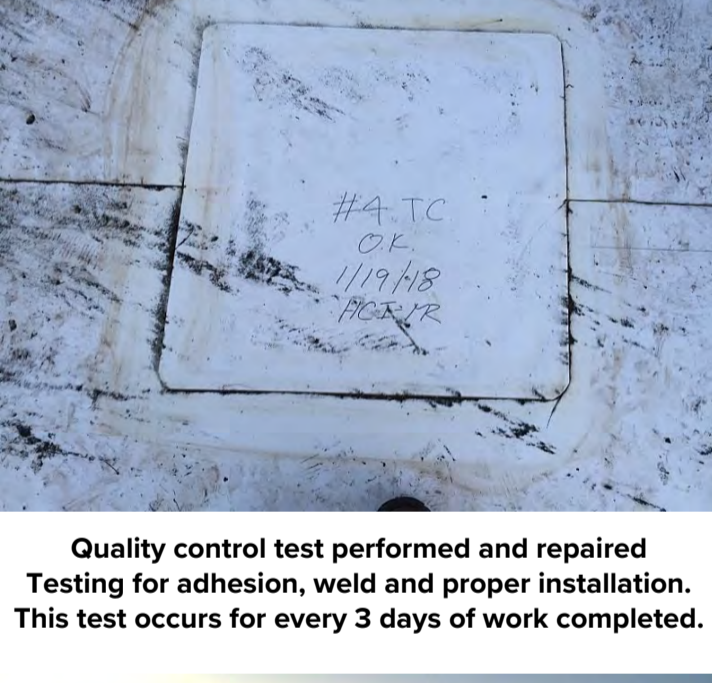
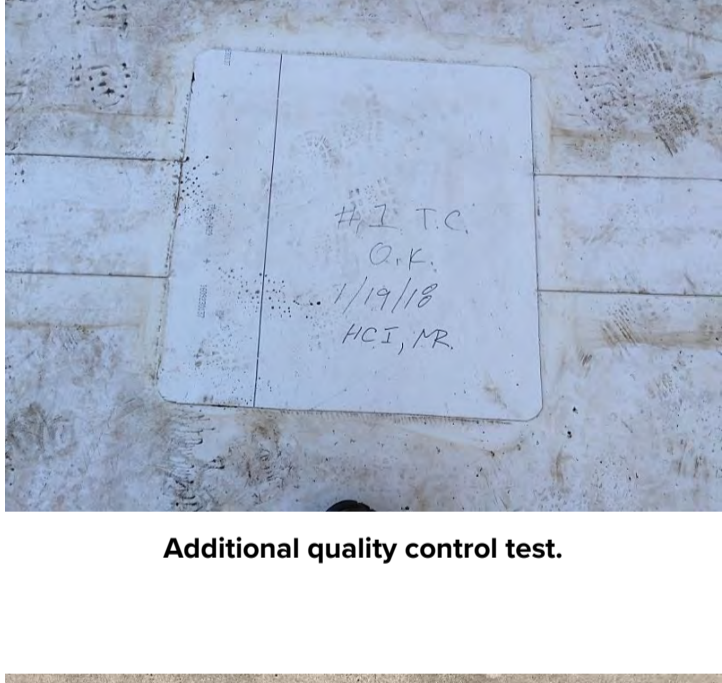
Plates installed by specs.

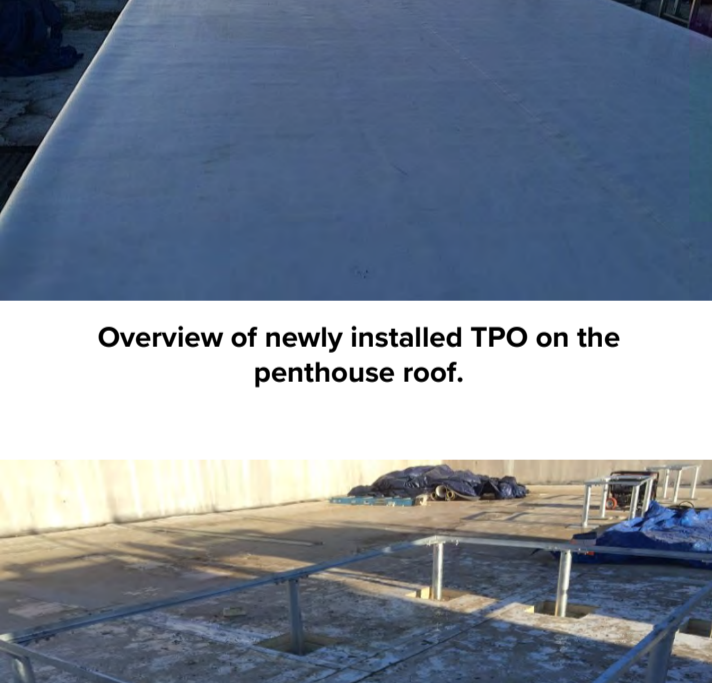
Rsva adhesive applied to bond invinsa board.

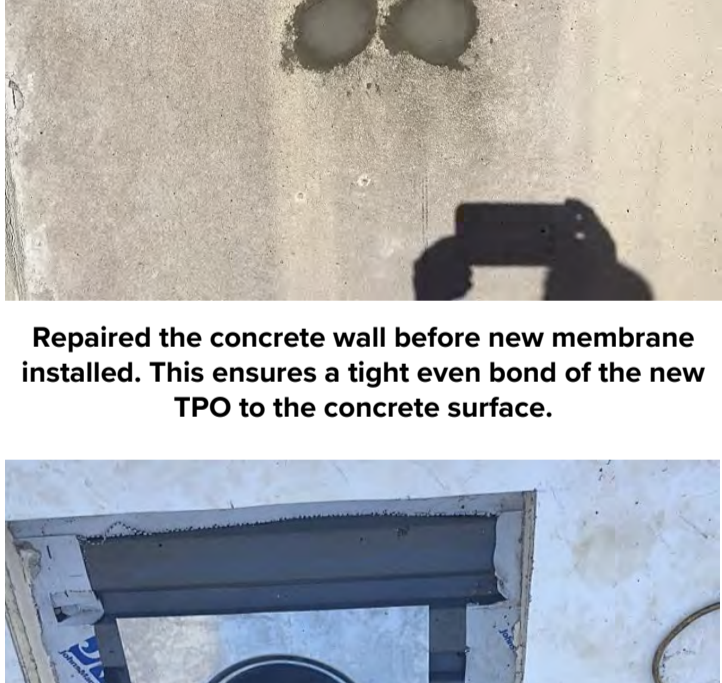
New vapor barrier installed.
